**Flood Control Project Maintenance
Levee Inspections**

Maintenance Issue Types Only, Levee Inspection Report By Mile - Spring 2019

Reclamation District No. 0349 Sutter Island

Waterway	Bank	Unit Miles	Inspection Start/End	Inspector
Unit No. 01 Sacramento River	Right	1.59	03/19/2019 03/19/2019	David Julian

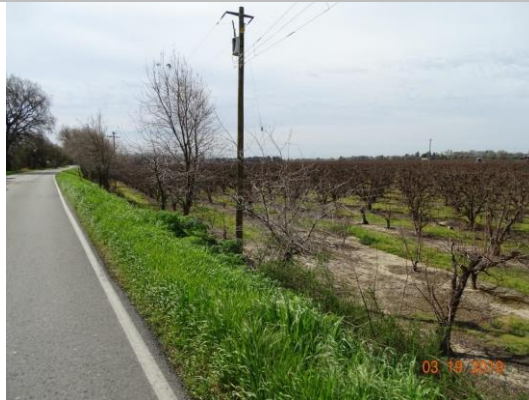
Photo 1 of 1 : SP_2019_RD0349_204_11_20190320_00030.jpg

View looking downstream at annual vegetation on the landside slope (Spring 2019).

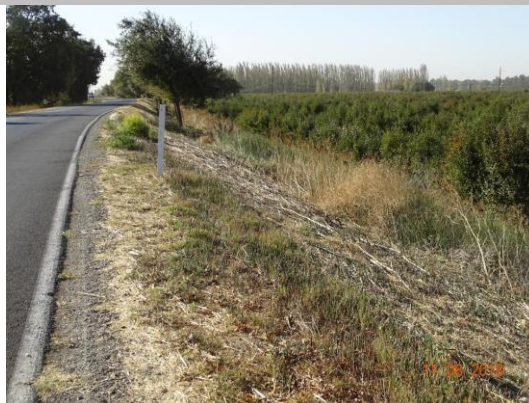
Photo 1 of 1 : SP_2019_RD0349_204_21_20190311_00005.jpg

Vegetation looking downstream on the landside slope (November 2018).

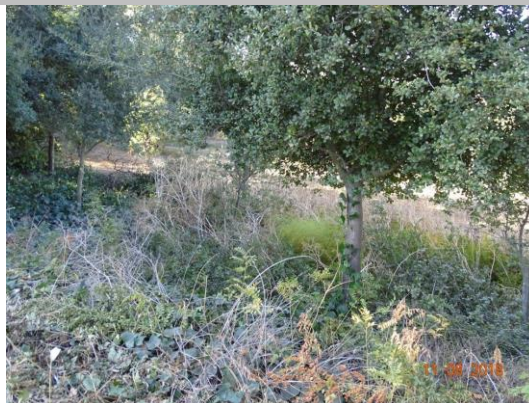
Photo 1 of 1 : SP_2019_RD0349_204_35_20190311_00010.jpg

View of vegetation on the landside toe (November 2018).

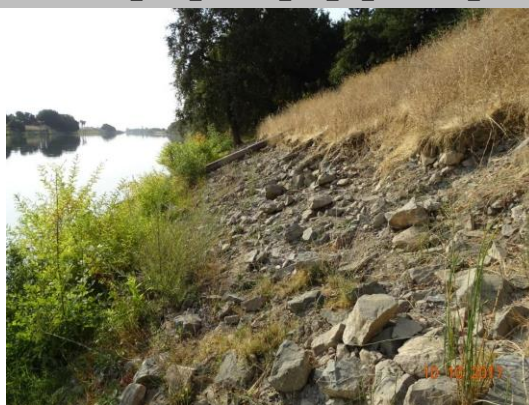
Photo 1 of 1 : SP_2019_RD0349_204_15_20190311_00002.jpg

LM Start	1.00	Rating **	M	Issue No.	15
LM End	1.06	Issue Type +	Ma	Location *	
Category	Supplemental			GPS Latitude/Longitude	
				Start	End
Item	2017 Storm Damage			38.312911 °	38.312131 °
				-121.578528 °	-121.578292 °
DWR ID	DWR_RD0349_01_f_2017_15

Comment Code					
Inspector Comment					
Levee Evaluation Comments					
Description:District Station 52+92 to 55+88, Sec. 06, T. 5 N. R. 4 E., M.D.M. Approximately 296 linear-feet of eroded area exists along the waterside levee slope of the Sacramento River (Unit 1). Erosion commences at approximately 3/4 of the way down the slope from the crown and extends into the rip rap. Some rip rap has been pulled off in this section.					
Site ID No:318					
Site Designation:LMA-145					
Repair Type: Erosion					
Rating:Area of Concern					
Field Date:7/28/2017					
Notes: slope too steep, vegetation too thick for clear inspection, no direct visual of damage

Waterside erosion at LM 1.02.

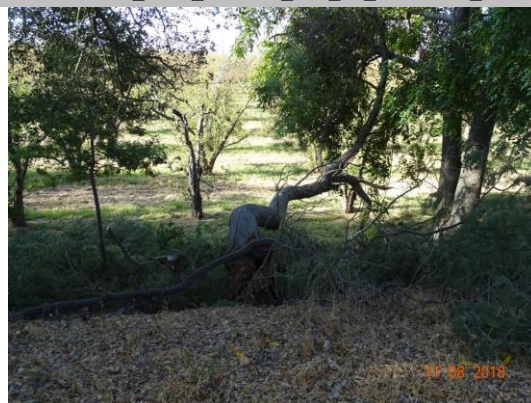
Photo 1 of 1 : SP_2019_RD0349_204_36_20190311_00011.jpg

LM Start	1.40	Rating **	M	Issue No.	36
LM End	1.40	Issue Type +	Ma	Location *	LS
Category	Earthen Levee			GPS Latitude/Longitude	
				Start	End
Item	Encroachments			38.307553 °	38.307553 °
				-121.575848 °	-121.575848 °
DWR ID	DWR_RD0349_01_f_2018_36				
Comment Code					
TR : Tree or limb					
Inspector Comment

View of fallen tree limb on the landside toe (November 2018).

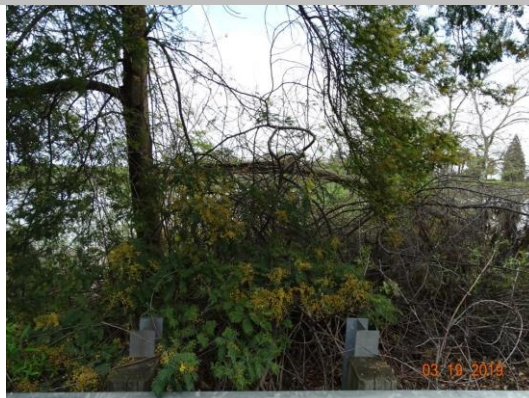
Photo 1 of 1 : SP_2019_RD0349_204_16_20190320_00031.jpg

View of thick trees on the waterside slope (Spring 2019).

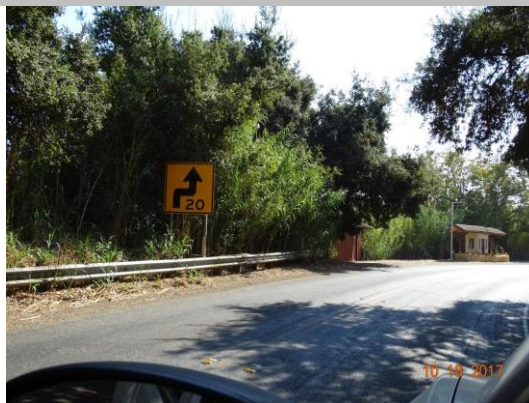
Photo 1 of 1 : SP_2019_RD0349_204_34_20190311_00009.jpg

LM Start	1.54	Rating **	U	Issue No.	34
LM End	1.58	Issue Type +	Ma	Location *	WS
Category	Earthen Levee			GPS Latitude/Longitude	
				Start	End
Item	Vegetation			38.305772 °	38.305252 °
				-121.574763 °	-121.574791 °
DWR ID	DWR_RD0349_01_f_2017_34				
Comment Code					
V2 : Remove the wild growth other than native grasses from the levee slopes.					
Inspector Comment					
Arundo completely blocks visibility and access to waterside of levee.

View of arundo on the waterside of levee

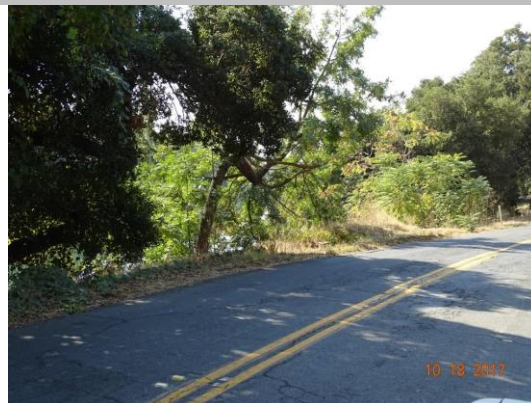
Photo 1 of 1 : SP_2019_RD0349_205_44_20190311_00035.jpg

Photo of waterside vegetation

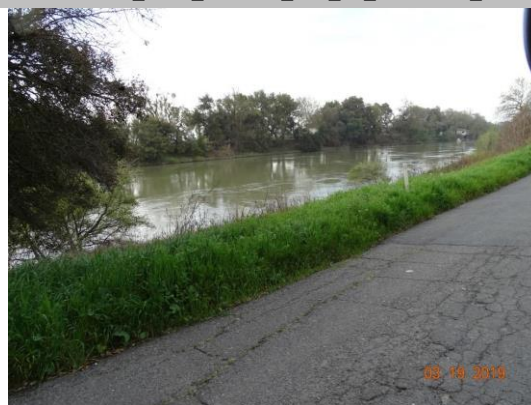
Photo 1 of 1 : SP_2019_RD0349_205_32_20190320_00104.jpg

LM Start	0.11	Rating **	M	Issue No.	32
LM End	3.10	Issue Type +	Ma	Location *	WS
Category	Earthen Levee			GPS Latitude/Longitude	
				Start	End
Item	Vegetation			38.304472 °	38.266327 °
				-121.576613 °	-121.588392 °
DWR ID	DWR_RD0349_02_s_2019_32				
Comment Code					
V1 : Control annual grass and weeds on the levee slopes and easements.					
Inspector Comment					
Remove annual vegetation from the waterside slope.

View looking downstream at annual vegetation on the waterside slope (Spring 2019).

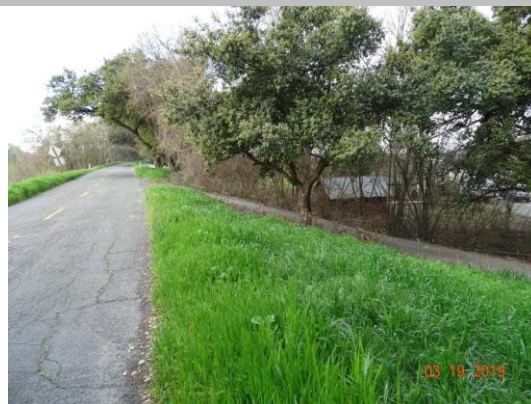
Photo 1 of 1 : SP_2019_RD0349_205_33_20190320_00105.jpg

LM Start	0.11	Rating **	M	Issue No.	33
LM End	3.10	Issue Type +	Ma	Location *	LS
Category	Earthen Levee			GPS Latitude/Longitude	
				Start	End
Item	Vegetation			38.304472 °	38.266322 °
				-121.576613 °	-121.588392 °
DWR ID	DWR_RD0349_02_s_2019_33				
Comment Code					
V1 : Control annual grass and weeds on the levee slopes and easements.					
Inspector Comment					
Remove grass and vegetation from the landside levee slope.

View looking downstream at annual vegetation on the landside slope (Spring 2019).

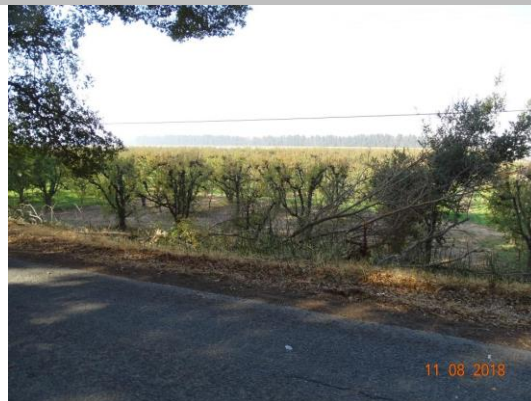
Photo 1 of 1 : SP_2019_RD0349_205_75_20190311_00046.jpg

View of downed tree on the landside slope (November 2018).

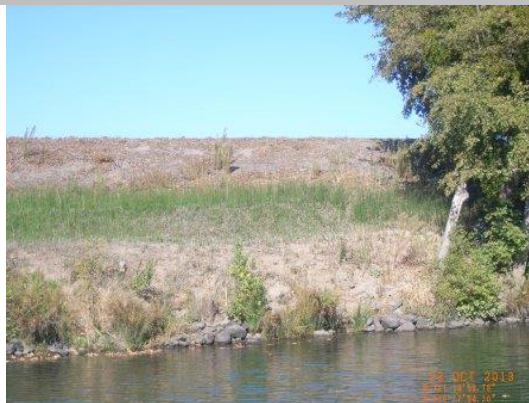
Photo 1 of 1 : SP_2019_RD0349_205_28_20190311_00013.jpg

LM Start	0.60	Rating **	M	Issue No.	28
LM End	0.72	Issue Type +	Ma	Location *	WS
Category	Supplemental			GPS Latitude/Longitude	
				Start	End
Item	2017 USACE Erosion Survey, DRAFT			38.298897 °	38.297384 °
				-121.581571 °	-121.582176 °
DWR ID	DWR_RD0349_02_f_2018_28				
Comment Code					
Inspector Comment					
2017 Site ID: STM 25.5 R					
Status: Eroding					
2017 Field Notes: No observed change.					
Site History: 2010 - Small maintenance, erosion into the toe. 2011 - Minor new erosion at toe. 2015 - Minor new erosion at toe, new tree pop-out. 2016 - Fresh scarp at downstream end.

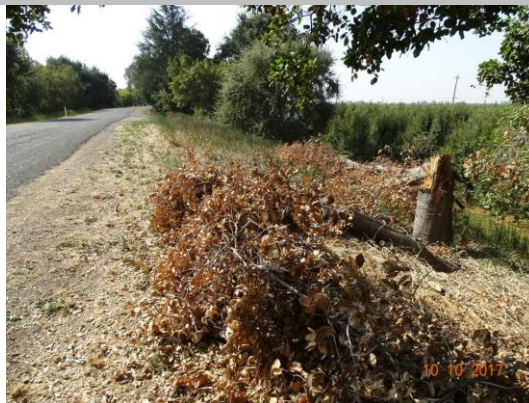
Photo 1 of 1 : SP_2019_RD0349_205_7_20190311_00006.jpg

Fallen tree on landside slope.

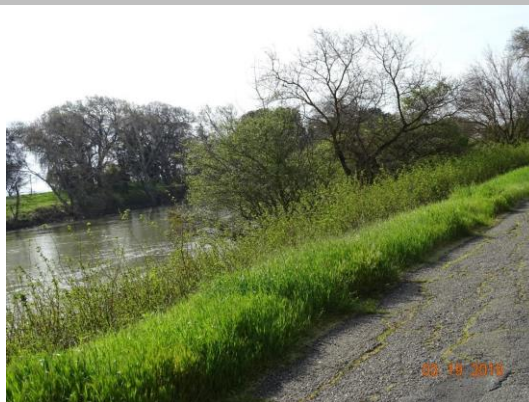
Photo 1 of 1 : SP_2019_RD0349_205_79_20190320_00108.jpg

View looking downstream of wild growth on the waterside slope (Spring 2019).

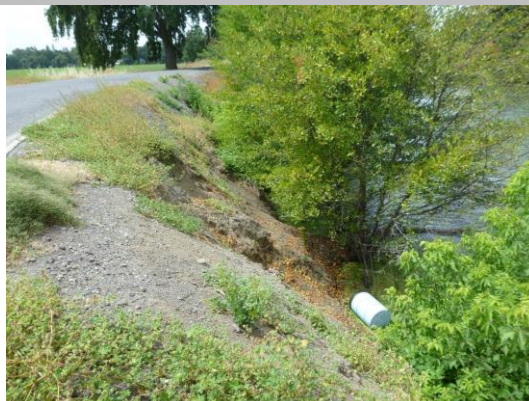
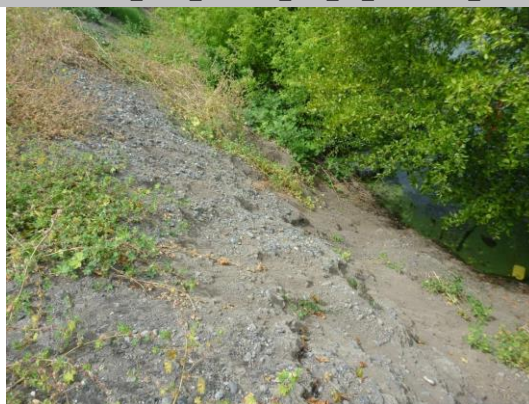
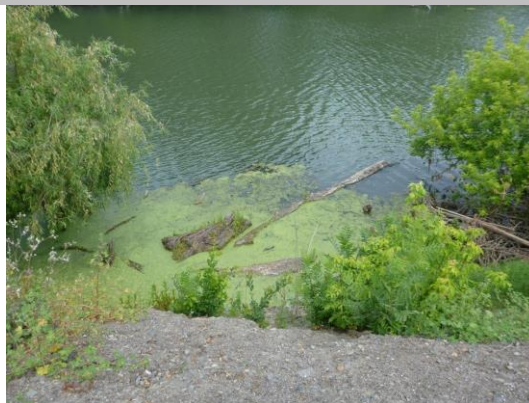
LM Start	1.33	Rating **	M	Issue No.	40
LM End	1.49	Issue Type +	Ma	Location *	
Category	Supplemental			GPS Latitude/Longitude	
				Start	End
Item	2017 Storm Damage			38.288727 °	38.286475 °
				-121.583823 °	-121.585026 °
DWR ID	DWR_RD0349_02_f_2017_40				
Comment Code					
Inspector Comment					
Levee Evaluation Comments					
Description:					
Site ID No:66					
Site Designation:DWR_RD0349_02_s_2012_28					
Repair Type: Erosion					
Rating:Area of Concern					
Field Date:6/7/2017					
Notes: dense vegetation and large trees hindered visibility; slope riprap appeared failing in some parts

LM Start	1.33	Rating **	M	Issue No.	40 (cont)
LM End	1.49	Issue Type +	Ma	Location *	
Category	Supplemental			GPS Latitude/Longitude	
				Start	End
Item	2017 Storm Damage			38.288727 °	38.286475 °
				-121.583823 °	-121.585026 °
DWR ID	DWR_RD0349_02_f_2017_40				
Comment Code					
Inspector Comment					
Levee Evaluation Comments					
Description:					
Site ID No:66					
Site Designation:DWR_RD0349_02_s_2012_28					
Repair Type: Erosion					
Rating:Area of Concern					
Field Date:6/7/2017					
Notes: dense vegetation and large trees hindered visibility; slope riprap appeared failing in some parts

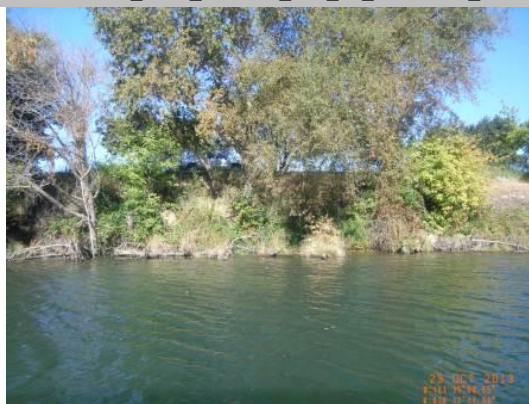
Photo 1 of 1 : SP_2019_RD0349_205_27_20190311_00012.jpg

LM Start	1.33	Rating **	A/W	Issue No.	27
LM End	1.49	Issue Type +	Ma	Location *	WS
Category	Supplemental			GPS Latitude/Longitude	
				Start	End
Item	2017 USACE Erosion Survey, DRAFT			38.288727 °	38.286475 °
				-121.583823 °	-121.585026 °
DWR ID	DWR_RD0349_02_f_2018_27

Comment Code					
Inspector Comment					
2017 Site ID: STM 24.7 R					
Status: Critical					
2017 Field Notes: No observed change.					
Site History: 1997 - Erosion of very sandy levee behind large stand of riparian vegetation on top right bank. Dry ravel of sand. 1999 - Quarry waste rock was dumped down the levee slope; poor repair job; still eroding in places. Eroding at midslope off fabric. 2005 - Length revised, only the middle 150 - 200 ft are eroding. 2006 - Some rock/small material dumped down the bank but it is slowly unraveling. Upstream end is unraveling faster. Steep slope with poor gradation so fines are washing out. 2010 - Lots of overhanging trees and erosion pockets. 2011 - This site is upgraded to CRITICAL. Near vertical bank at the downstream end. New erosion at various locations throughout the site.

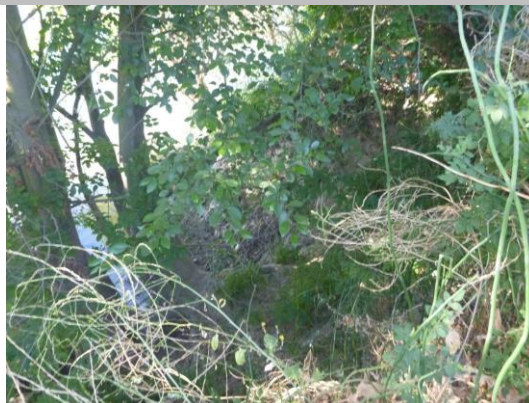
Photo 2 of 2 : SP_2019_RD0349_205_37_20190311_00023.jpg

LM Start	1.48	Rating **	A/W	Issue No.	37 (cont)
LM End	1.49	Issue Type +	Ma	Location *	
Category	Supplemental			GPS Latitude/Longitude	
				Start	End
Item	2017 Storm Damage			38.286708 °	38.286569 °
				-121.584839 °	-121.585042 °
DWR ID	DWR_RD0349_02_f_2017_37				
Comment Code					
Inspector Comment					
Levee Evaluation Comments					
Description:District Station 78+51 to 79+28, Sec. 18, T. 5 N. R. 4 E., M.D.M. Approximately 77 linear feet of erosion and scour exist along the water side slope of Steamboat Slough (Unit 2). The erosion area commences approximately halfway down the slope from the levee crown and extends to the waterside toe around existing trees. No rip rap is visible in this area.					
Site ID No:323					
Site Designation:LMA-150					
Repair Type: Erosion					
Rating:Area of Concern					
Field Date:7/28/2017					
Notes: no berm

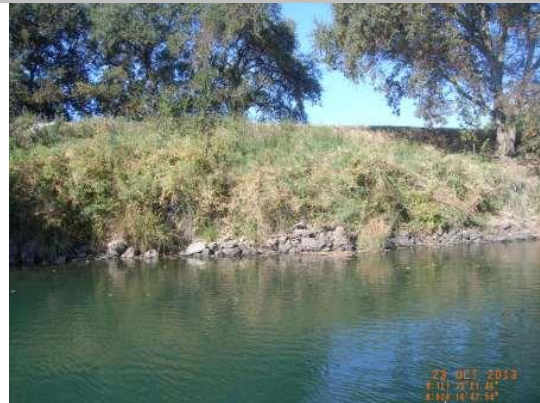
Photo 1 of 1 : SP_2019_RD0349_205_26_20190311_00011.jpg

LM Start	2.04	Rating **	M	Issue No.	26
LM End	2.05	Issue Type +	Ma	Location *	WS
Category	Supplemental			GPS Latitude/Longitude	
				Start	End
Item	2017 USACE Erosion Survey, DRAFT			38.280069 °	38.279919 °
				-121.589443 °	-121.589438 °
DWR ID	DWR_RD0349_02_f_2018_26				
Comment Code					
Inspector Comment					
2017 Site ID: STM 24.1 R					
Status: Eroding					
2017 Field Notes: No observed change.					
Site History: 2011 - Small scallop caused by erosion and wave wash.

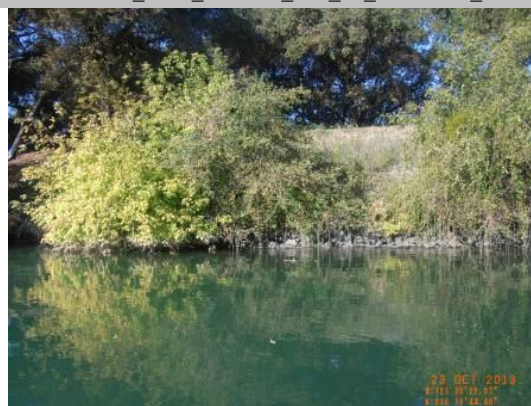
Photo 1 of 1 : SP_2019_RD0349_205_25_20190311_00010.jpg

LM Start	2.11	Rating **	A/W	Issue No.	25
LM End	2.14	Issue Type +	Ma	Location *	WS
Category	Supplemental			GPS Latitude/Longitude	
				Start	End
Item	2017 USACE Erosion Survey, DRAFT			38.279017 °	38.278597 °
				-121.589615 °	-121.589854 °
DWR ID	DWR_RD0349_02_f_2018_25				
Comment Code					
Inspector Comment					
2017 Site ID: STM 23.9 R Status: Eroding 2017 Field Notes: No observed change. Site History: 1997 - Top right bank has retreated into the levee. Site is between two rock sites. 1999 - Downstream half of the reach repaired with rock. 2000 - Trees leaning into the water. 2010 - Site appears worse. 2011 - New erosion at the toe. 2013 - Short vertical sections observed at upstream end. 2015 - Minor new erosion.

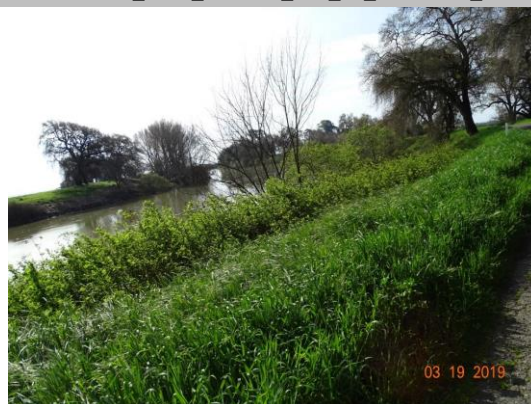
Photo 1 of 1 : SP_2019_RD0349_205_92_20190320_00111.jpg

View looking downstream of thick wild growth on the waterside slope (Spring 2019).

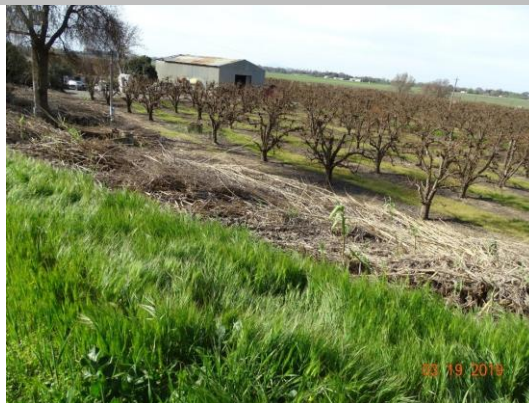
Photo 1 of 2 : SP_2019_RD0349_205_60_20190320_00112.jpg

View of arundo that has been chopped and sprayed on the landside slope (Spring 2019).

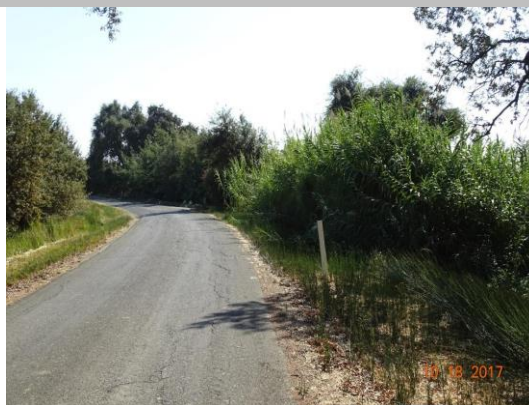
Photo 2 of 2 : SP_2019_RD0349_205_60_20190311_00040.jpg

View of arundo and other vegetation on landside slope

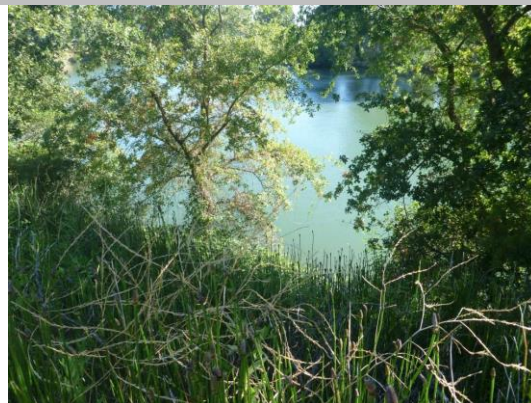
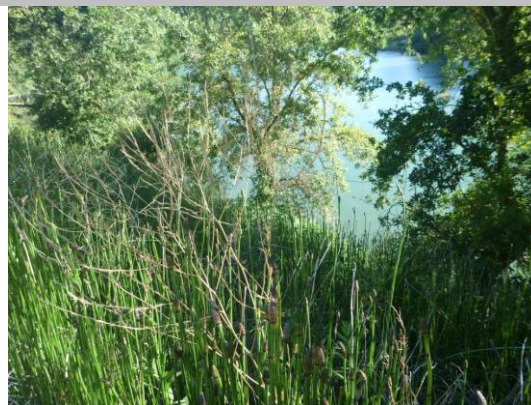
LM Start	2.43	Rating **	A/W	Issue No.	42
LM End	2.44	Issue Type +	Ma	Location *	
Category	Supplemental			GPS Latitude/Longitude	
				Start	End
Item	2017 Storm Damage			38.275131 °	38.275036 °
				-121.590594 °	-121.590461 °
DWR ID	DWR_RD0349_02_f_2017_42				
Comment Code					
Inspector Comment					
Levee Evaluation Comments					
Description:District Station 128+76 to 129+27, Sec. 13, T. 5 N. R. 3 E., M.D.M. Approximately 51 linear feet of erosion exists along the water side slope of Steamboat Slough (Unit 2). The erosion area commences approximately 3/4 of the way down the slope from the levee crown and extends to the waterside toe around existing trees. No rip rap is visible in this area.					
Site ID No:325					
Site Designation:LMA-152					
Repair Type: Erosion					
Rating:Area of Concern					
Field Date:7/28/2017					
Notes: access very difficult, steep slope, dense brush

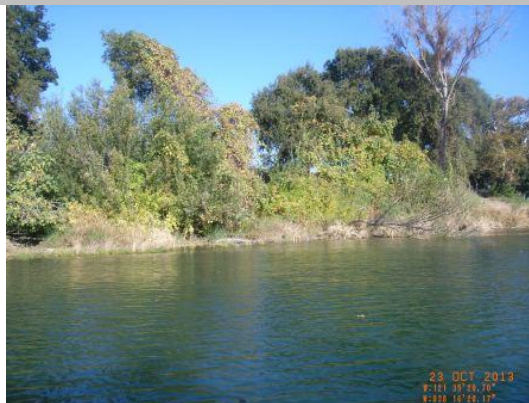
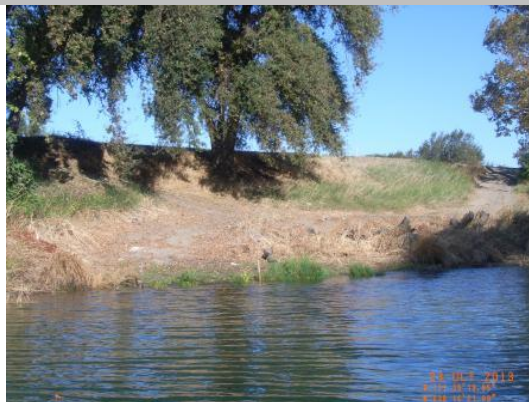
LM Start	2.56	Rating **	A/W	Issue No.	24
LM End	2.69	Issue Type +	Ma	Location *	WS
Category	Supplemental			GPS Latitude/Longitude	
				Start	End
Item	2017 USACE Erosion Survey, DRAFT			38.273854 °	38.271998 °
				-121.588745 °	-121.589424 °
DWR ID	DWR_RD0349_02_f_2018_24				
Comment Code					
Inspector Comment					
2017 Site ID: STM 23.6 R					
Status: Eroding					
2017 Field Notes: Previously observed quarry stone at the downstream end is now gone. Significant erosion at upstream end. Fresh sedimentation on the downstream end.					
Site History: 2011 - Toe scour at the tidal zone. 2015 - New tree pop-out and minor new erosion. 2016 - New erosion at upstream end.

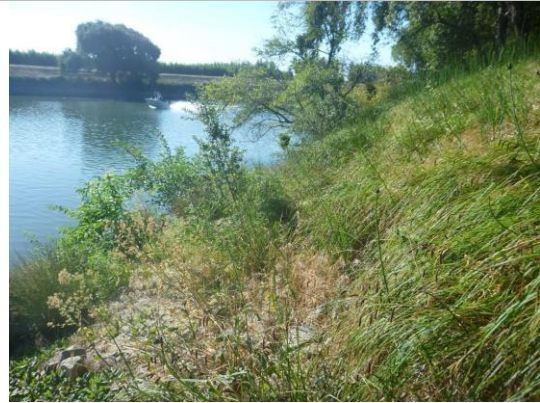
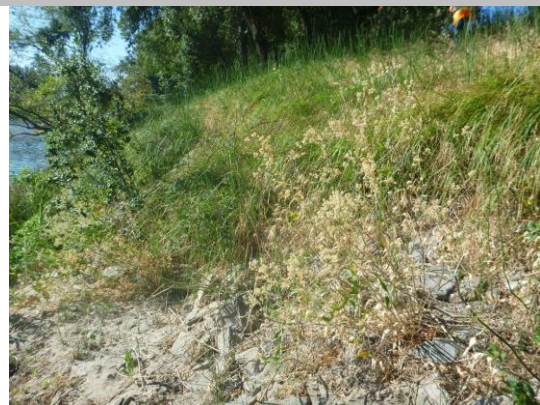
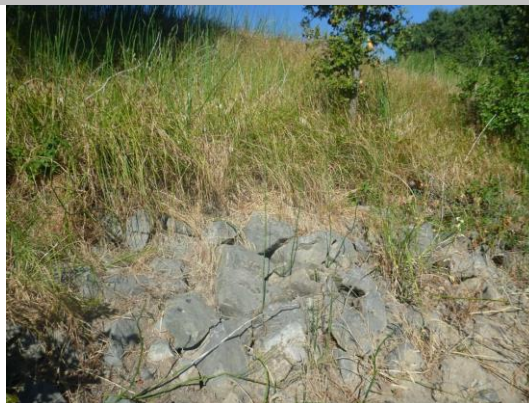
LM Start	2.56	Rating **	A/W	Issue No.	43
LM End	2.59	Issue Type +	Ma	Location *	
Category	Supplemental			GPS Latitude/Longitude	
				Start	End
Item	2017 Storm Damage			38.273769 °	38.273386 °
				-121.588742 °	-121.588672 °
DWR ID	DWR_RD0349_02_f _ 2017_43				
Comment Code					
Inspector Comment					
Levee Evaluation Comments					
Description:District Station 135+81 to 137+00, Sec. 13, T. 5 N. R. 3 E., M.D.M. Approximately 119 linear feet of sloughing exists due to scour along the water side toe of Steamboat Slough (Unit 2). The erosion area commences approximately 3/4 of the way down the slope from the levee crown and extends to the waterside toe. No rip rap is visible in this area.					
Site ID No:326					
Site Designation:LMA-153					
Repair Type: Erosion					
Rating:Area of Concern					
Field Date:7/28/2017					
Notes: no berm

LM Start	2.56	Rating **	A/W	Issue No.	43 (cont)
LM End	2.59	Issue Type +	Ma	Location *	
Category	Supplemental			GPS Latitude/Longitude	
				Start	End
Item	2017 Storm Damage			38.273769 °	38.273386 °
				-121.588742 °	-121.588672 °
DWR ID	DWR_RD0349_02_f _ 2017_43				
Comment Code					
Inspector Comment					
Levee Evaluation Comments					
Description:District Station 135+81 to 137+00, Sec. 13, T. 5 N. R. 3 E., M.D.M. Approximately 119 linear feet of sloughing exists due to scour along the water side toe of Steamboat Slough (Unit 2). The erosion area commences approximately 3/4 of the way down the slope from the levee crown and extends to the waterside toe. No rip rap is visible in this area.					
Site ID No:326					
Site Designation:LMA-153					
Repair Type: Erosion					
Rating:Area of Concern					
Field Date:7/28/2017					
Notes: no berm

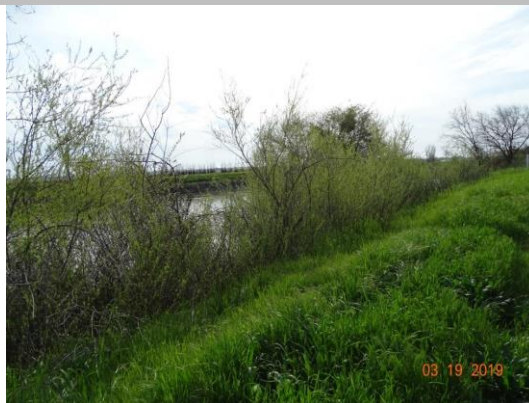
Photo 1 of 1 : SP_2019_RD0349_205_98_20190320_00114.jpg

View looking downstream at the wild growth on the waterside slope (Spring 2019).

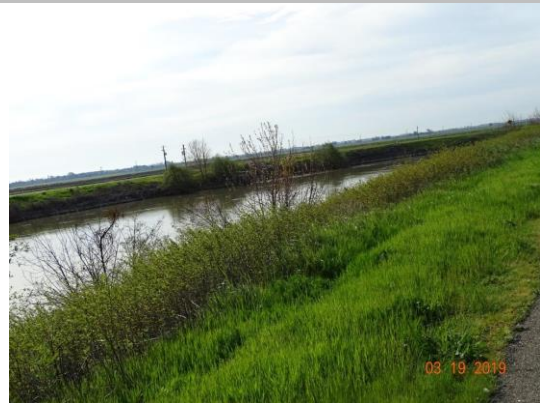
Photo 1 of 1 : SP_2019_RD0349_205_102_20190320_00115.jpg

View looking downstream at wild growth on the waterside slope (Spring 2019).

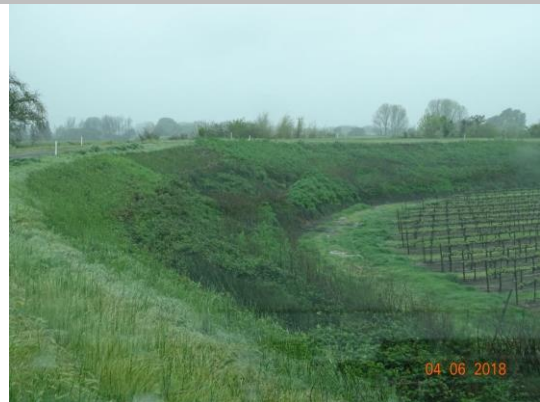
Photo 1 of 1 : SP_2019_RD0349_205_62_20190311_00042.jpg

View of berry vines

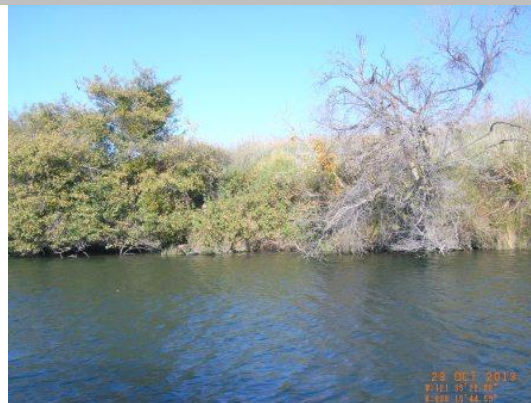
Photo 1 of 1 : SP_2019_RD0349_205_23_20190311_00007.jpg

LM Start	3.38	Rating **	M	Issue No.	23
LM End	3.49	Issue Type +	Ma	Location *	WS
Category	Supplemental			GPS Latitude/Longitude	
				Start	End
Item	2017 USACE Erosion Survey, DRAFT			38.262510 °	38.262533 °
				-121.589481 °	-121.591690 °
DWR ID	DWR_RD0349_02_f_2018_23				
Comment Code					
Inspector Comment					
2017 Site ID: STM 22.8 R					
Status: Eroding					
2017 Field Notes: No observed change.					
Site History: 2010 - Slumping sections on the lower bank, appears to be scouring around the trees. 2011 - Soil beach at toe.

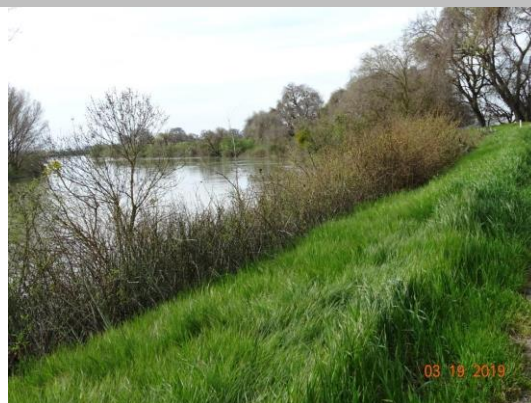
Photo 1 of 1 : SP_2019_RD0349_205_104_20190320_00117.jpg

View looking downstream at wild growth on the waterside slope (Spring 2019).

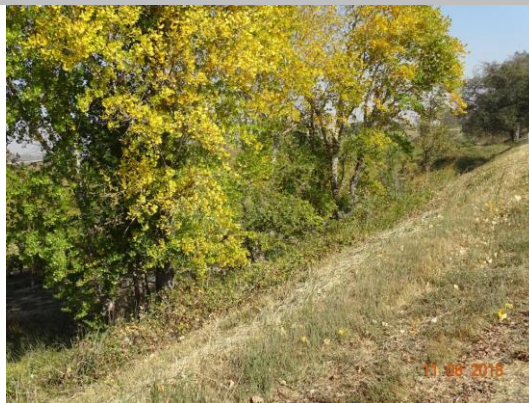
Photo 1 of 1 : SP_2019_RD0349_205_31_20190311_00015.jpg

View looking downstream of vegetation part way down the landside slope (November 2018).

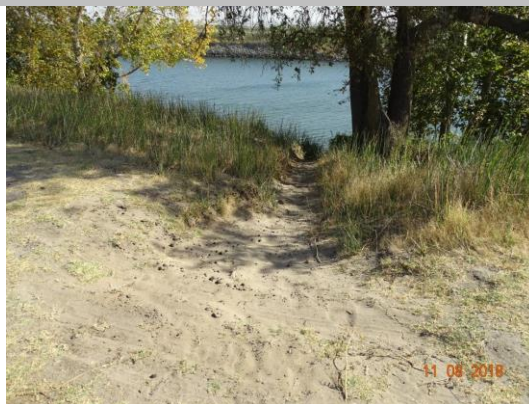
Photo 1 of 1 : SP_2019_RD0349_205_35_20190311_00019.jpg

View of footpath going down the waterside slope (November 2018).

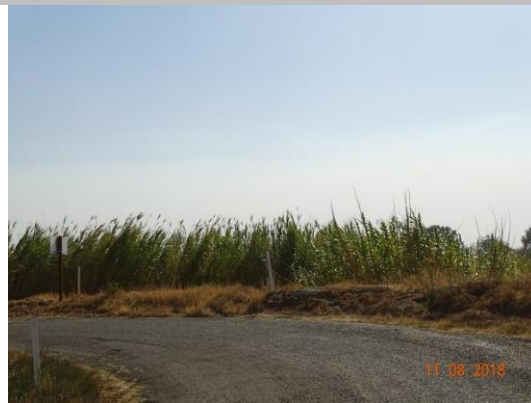
Photo 1 of 1 : SP_2019_RD0349_205_30_20190311_00014.jpg

View of arundo on the waterside slope (November 2018).

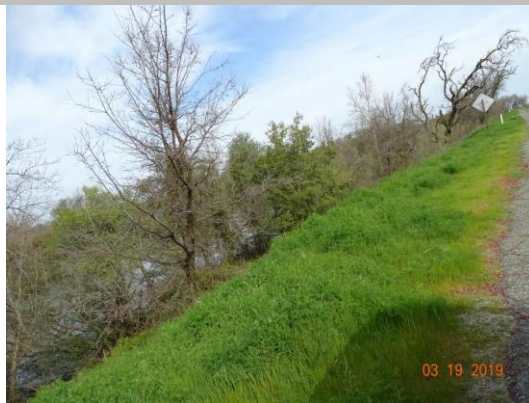
Photo 1 of 1 : SP_2019_RD0349_206_33_20190320_00083.jpg

View looking upstream at annual vegetation on the waterside slope (Spring 2019).

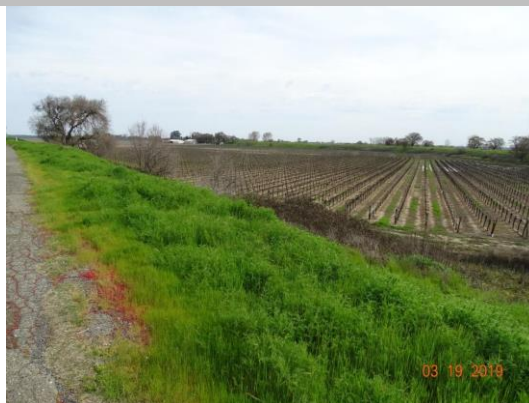
Photo 1 of 1 : SP_2019_RD0349_206_32_20190320_00084.jpg

View looking upstream at annual vegetation on the landside slope (Spring 2019).

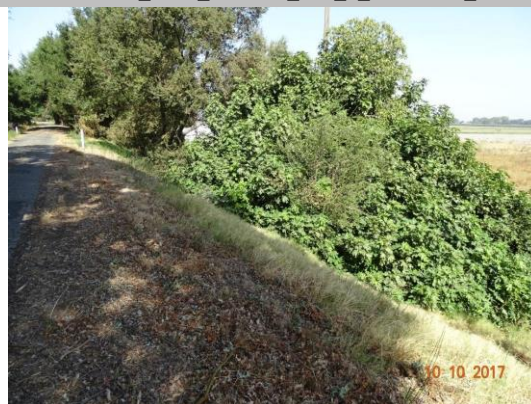
Photo 1 of 1 : SP_2019_RD0349_206_8_20190311_00001.jpg

View of trees on landside slope

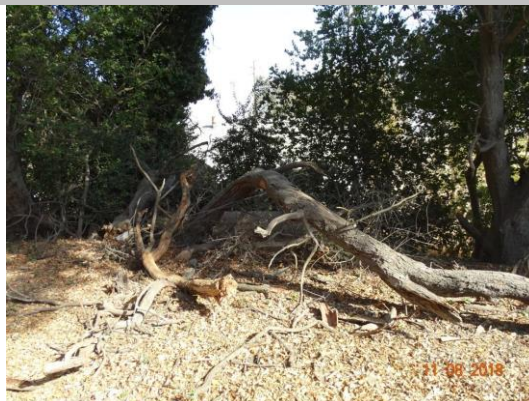
Photo 1 of 1 : SP_2019_RD0349_206_67_20190311_00009.jpg

View of down tree on the land side shoulder (November 2018).

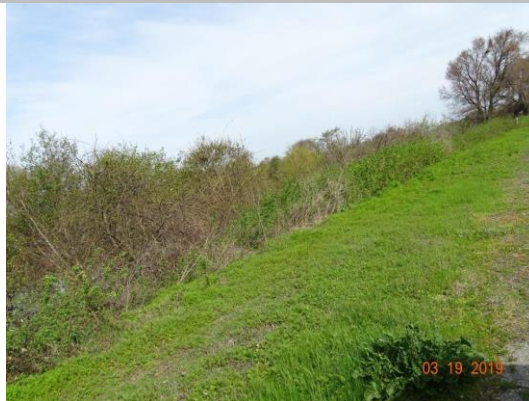
Photo 1 of 1 : SP_2019_RD0349_206_48_20190320_00091.jpg

View looking upstream at thick wild growth within 20 feet of the waterside shoulder (Spring 2019).

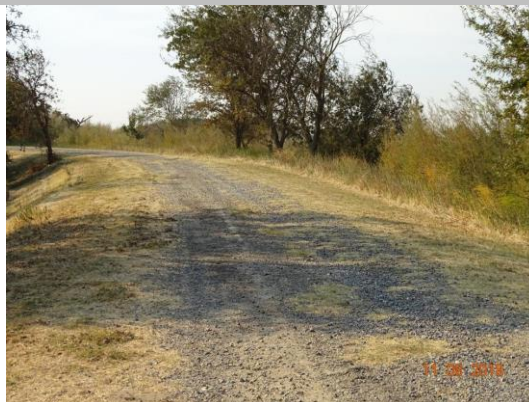
Photo 1 of 1 : SP_2019_RD0349_206_100_20190311_00015.jpg

View looking downstream at vegetation off the waterside shoulder (November 2018).

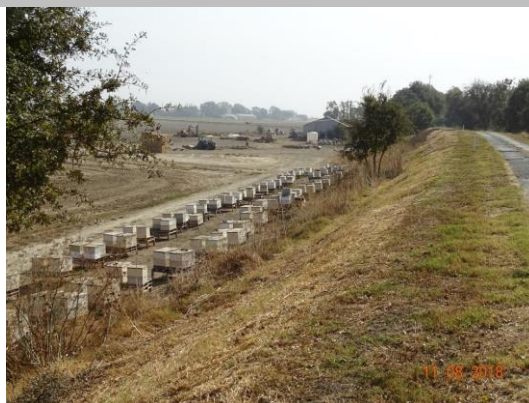
Photo 1 of 1 : SP_2019_RD0349_206_106_20190311_00019.jpg

View of vegetation on slope

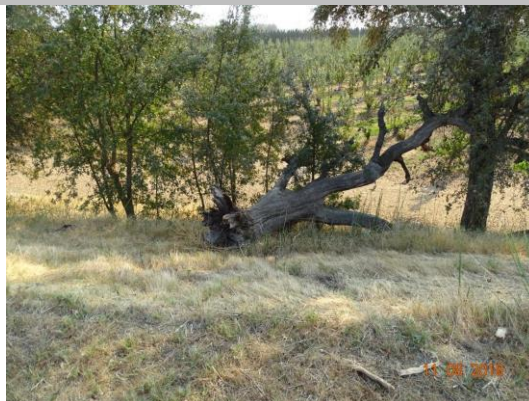
Photo 1 of 1 : SP_2019_RD0349_206_102_20190311_00016.jpg

View of tree on the landside slope (November 2018).

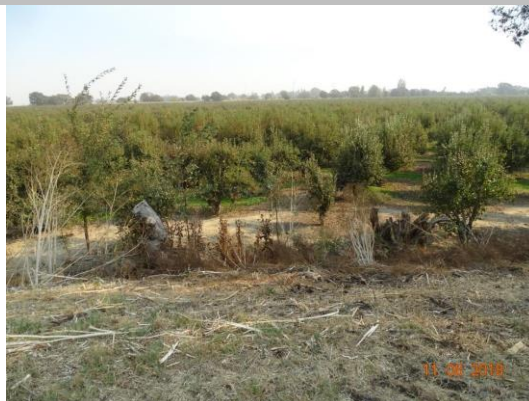
Photo 1 of 1 : SP_2019_RD0349_206_95_20190311_00013.jpg

View of down trees on the landside slope (November 2018).

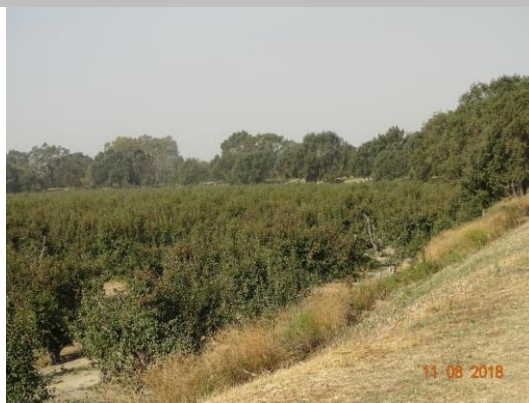
Photo 1 of 1 : SP_2019_RD0349_206_92_20190311_00012.jpg

View looking upstream at vegetation partway down the landside slope (November 2018).
